Chapter Ten - Building Condition Survey

In the summer of 2009 the Center for Great Neighborhoods of Covington (CGN) and NKAPC worked to conduct a building conditions analysis for structures in the Latonia study area. The survey included a field review of the exterior condition of buildings in all land use categories. Observations conducted by reviewers included physical information on buildings such as construction type and exterior surface as well as their use, occupancy status and overall condition.

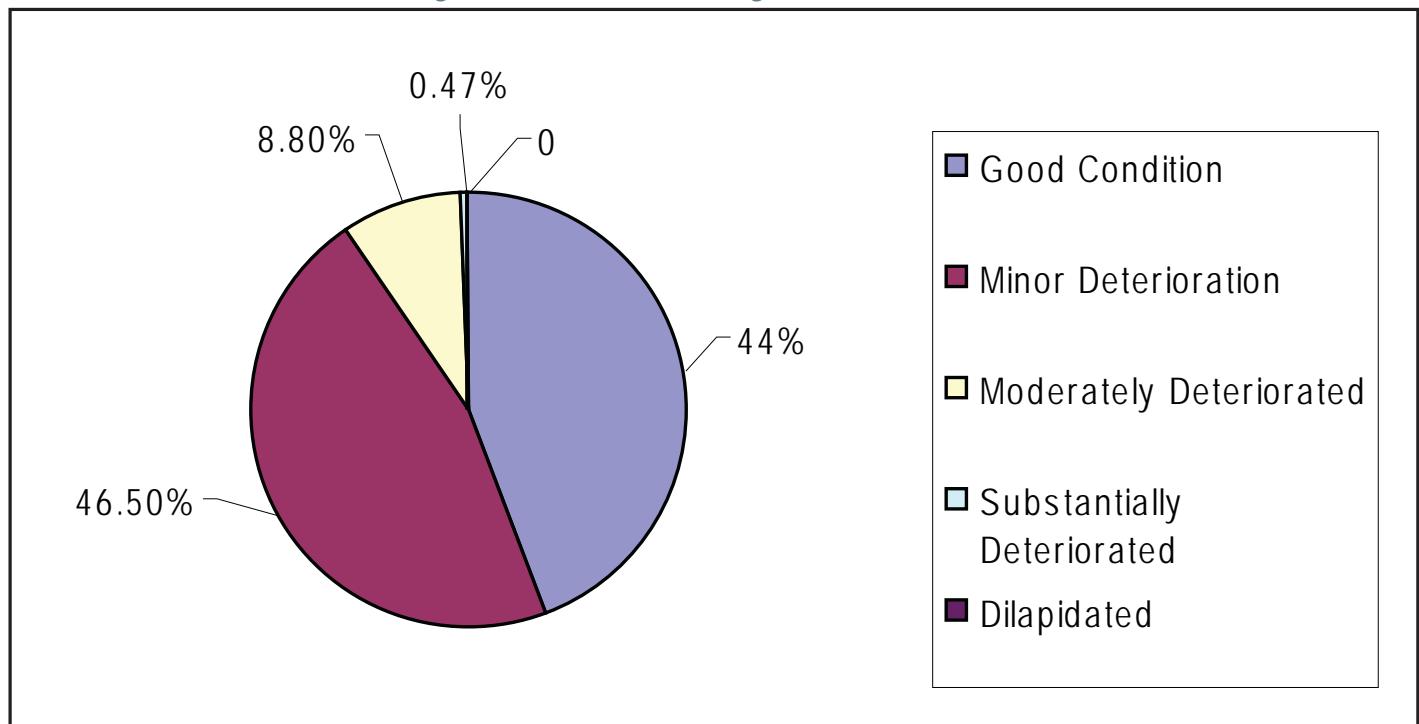
Chart 10.1 - Overall Building Condition Percentages

Considering the age of most structures in the area the average condition is very favorable. Chart 10.1 displays a breakdown of the overall building conditions in the Latonia area and shows that over 90% of the structures are in either Good Condition or have some indications of Minor Deterioration. The average condition of all structures in the area was 22.15.

- Work to retain existing properties reported as being in Good Condition.
- Explore programs to improve Minor and Moderately Deteriorated properties.
- Consider closer inspection (e.g. interior inspections) of Substantially Deteriorated and Dilapidated structures to determine if properties can be restored to good condition.
