The Banklick Watershed Action Plan

Kenton and Boone Counties, Kentucky

A Comprehensive Approach to Watershed Improvement

November 2005

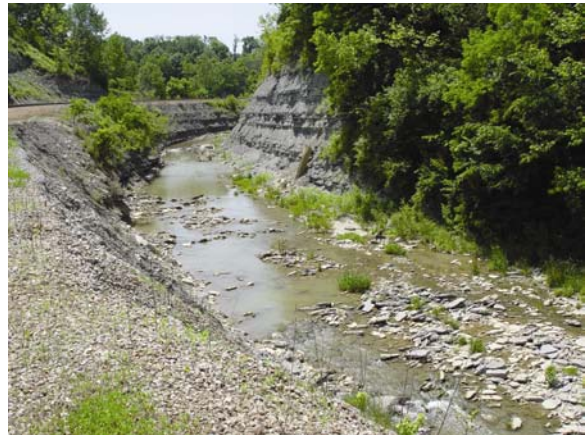
Banklick Creek re-channelized for railroad.
