Chapter 4 - Green Infrastructure

Latonia Small Area Study

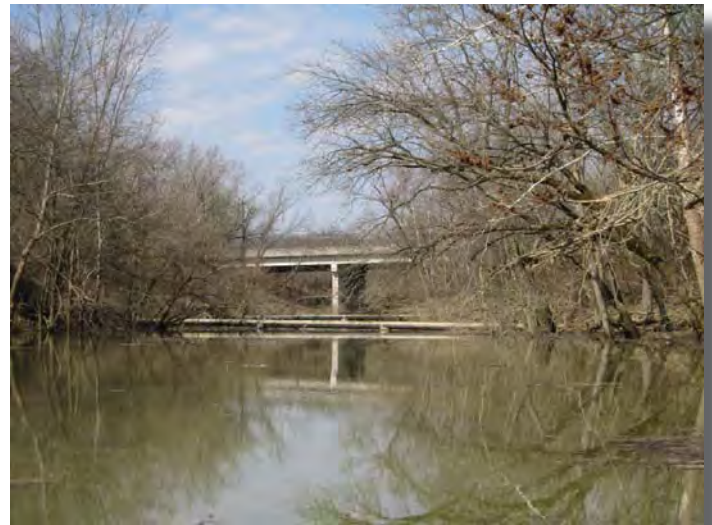
Figure 4.1 – Banklick Creek near East of Winston Avenue

Banklick Creek, a tributary to the Licking River, extends 19 miles beginning in the headwaters area in Boone County through Kenton County. Banklick Creek’s confluence with the Licking River is located adjacent to the south eastern boundary of the study area. At the beginning of the 21st century, the creek reflects a highly developed, ecologically compromised watershed . As mentioned previously, since 1998,

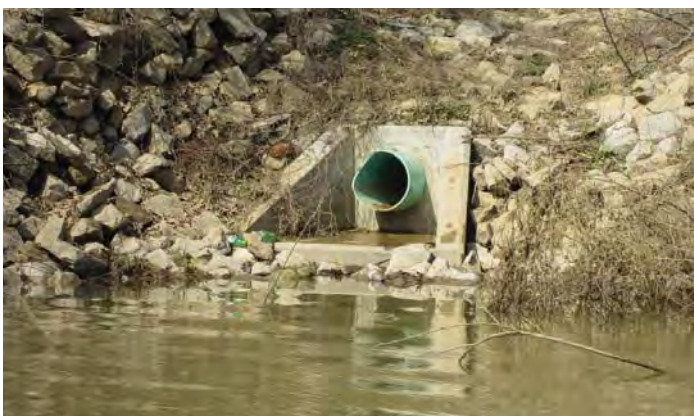
Figure 4.2 – Combined Sewer Overflow

There are presently 9 CSO's located along the boundary of the study area. Six outfalls are located on the Licking River such as the one shown in Figure 4.2 and three are located on Banklick Creek which forms the southern boundary of the study area.

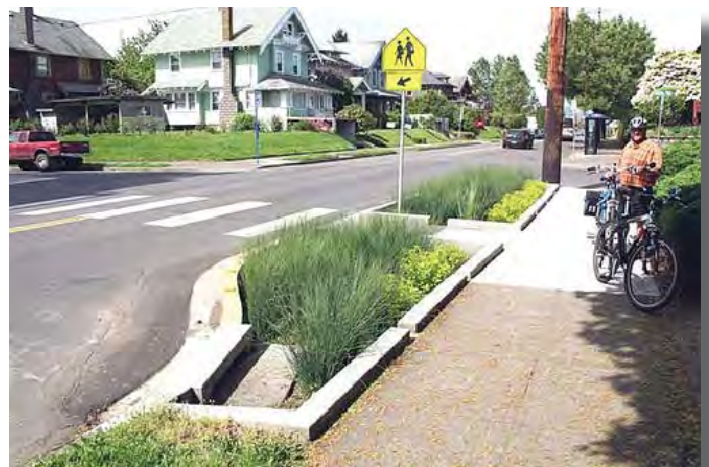
Figure 4.3 – Example of vegetated curb extension that captures stormwater before entering the storm sewer.

There are many different natural ways to reduce stormwater runoff, one of which is shown in Figure 4.3. These include bio-retention swales that can hold water during heavy rain events and clean the water as

it slowly percolates through the vegetation and soil, rain gardens that allow stormwater to infiltrate the soil quickly, vegetative medians, and curb extensions that reduce the amount of impervious surfaces, retention ponds, and green roofs that absorb most of the water that lands on them.

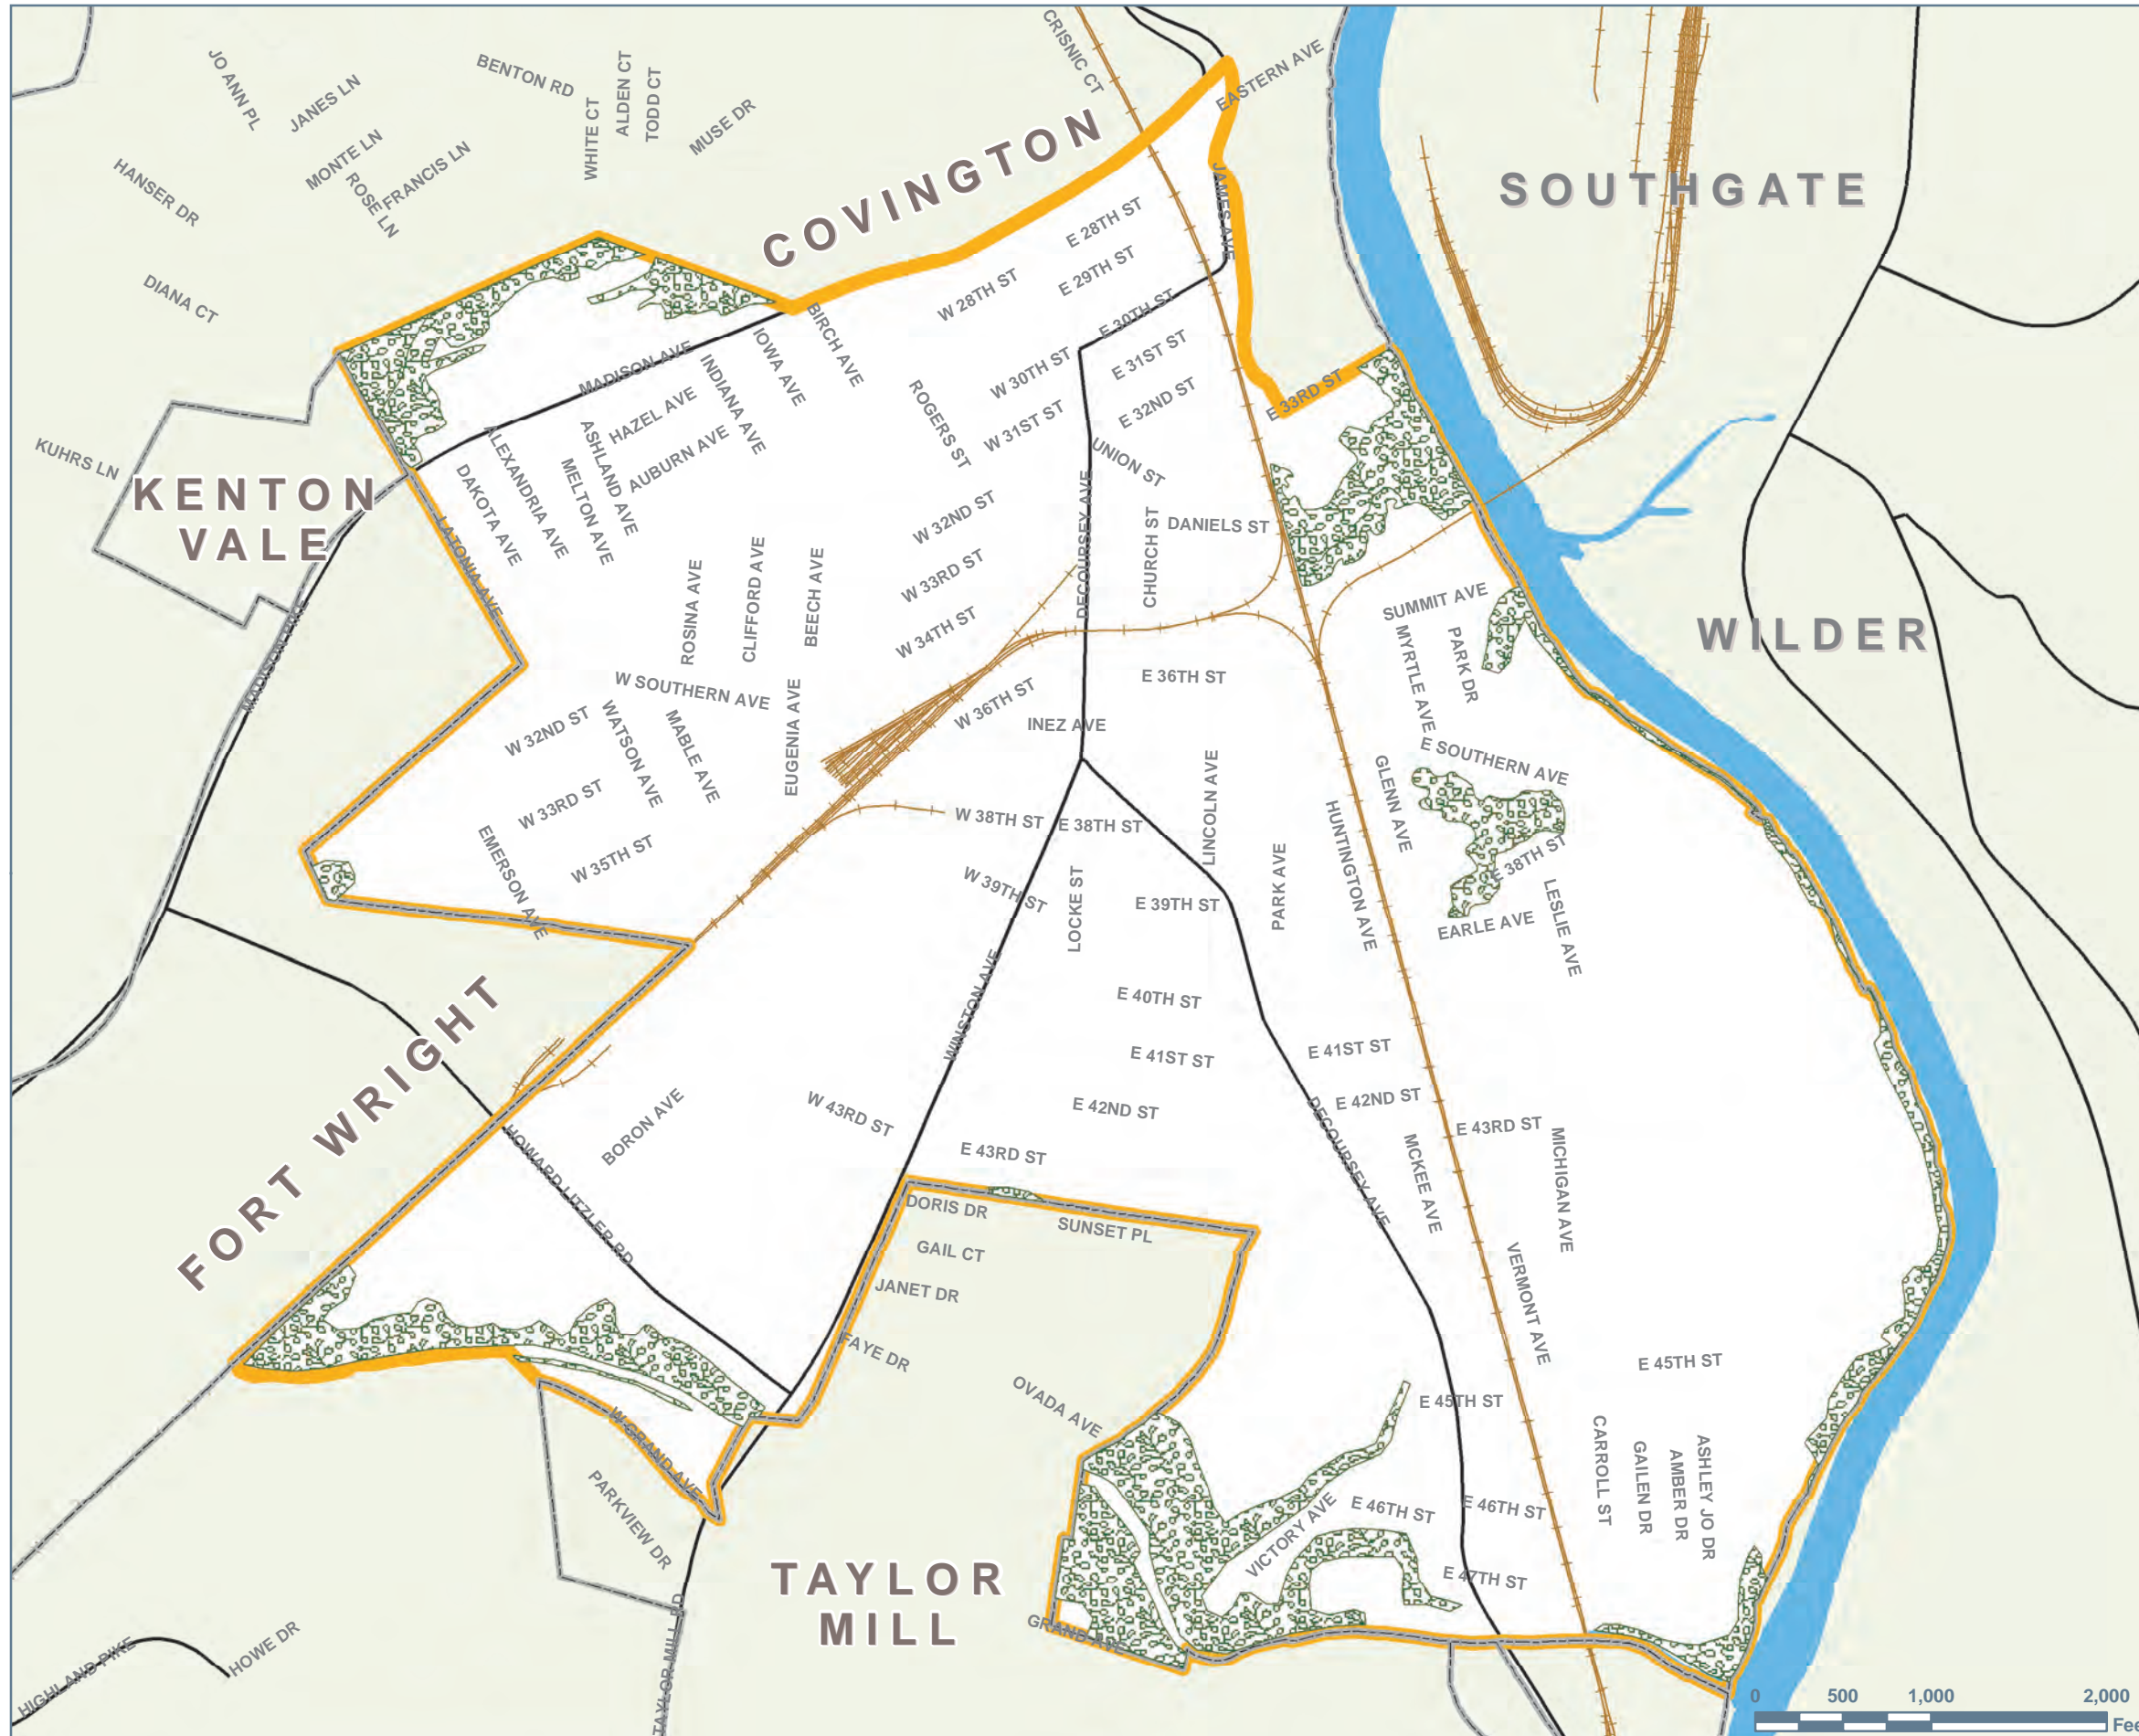
Map 4.3 Canopy Cover

Canopy Cover
Approximately 93 acres

Canopy Cover
Approximately 8% of study area

Large areas of canopy cover are located primarily within the floodplain areas of the Licking River and Banklick Creek as shown on Map 4.3. This canopy cover acts as a riparian buffer which is integral to the health of the streams. These buffers protect the stream by filtering sediment and pollutants, cool water temperature which is critical to the health of aquatic species and stabilizes bank erosion.

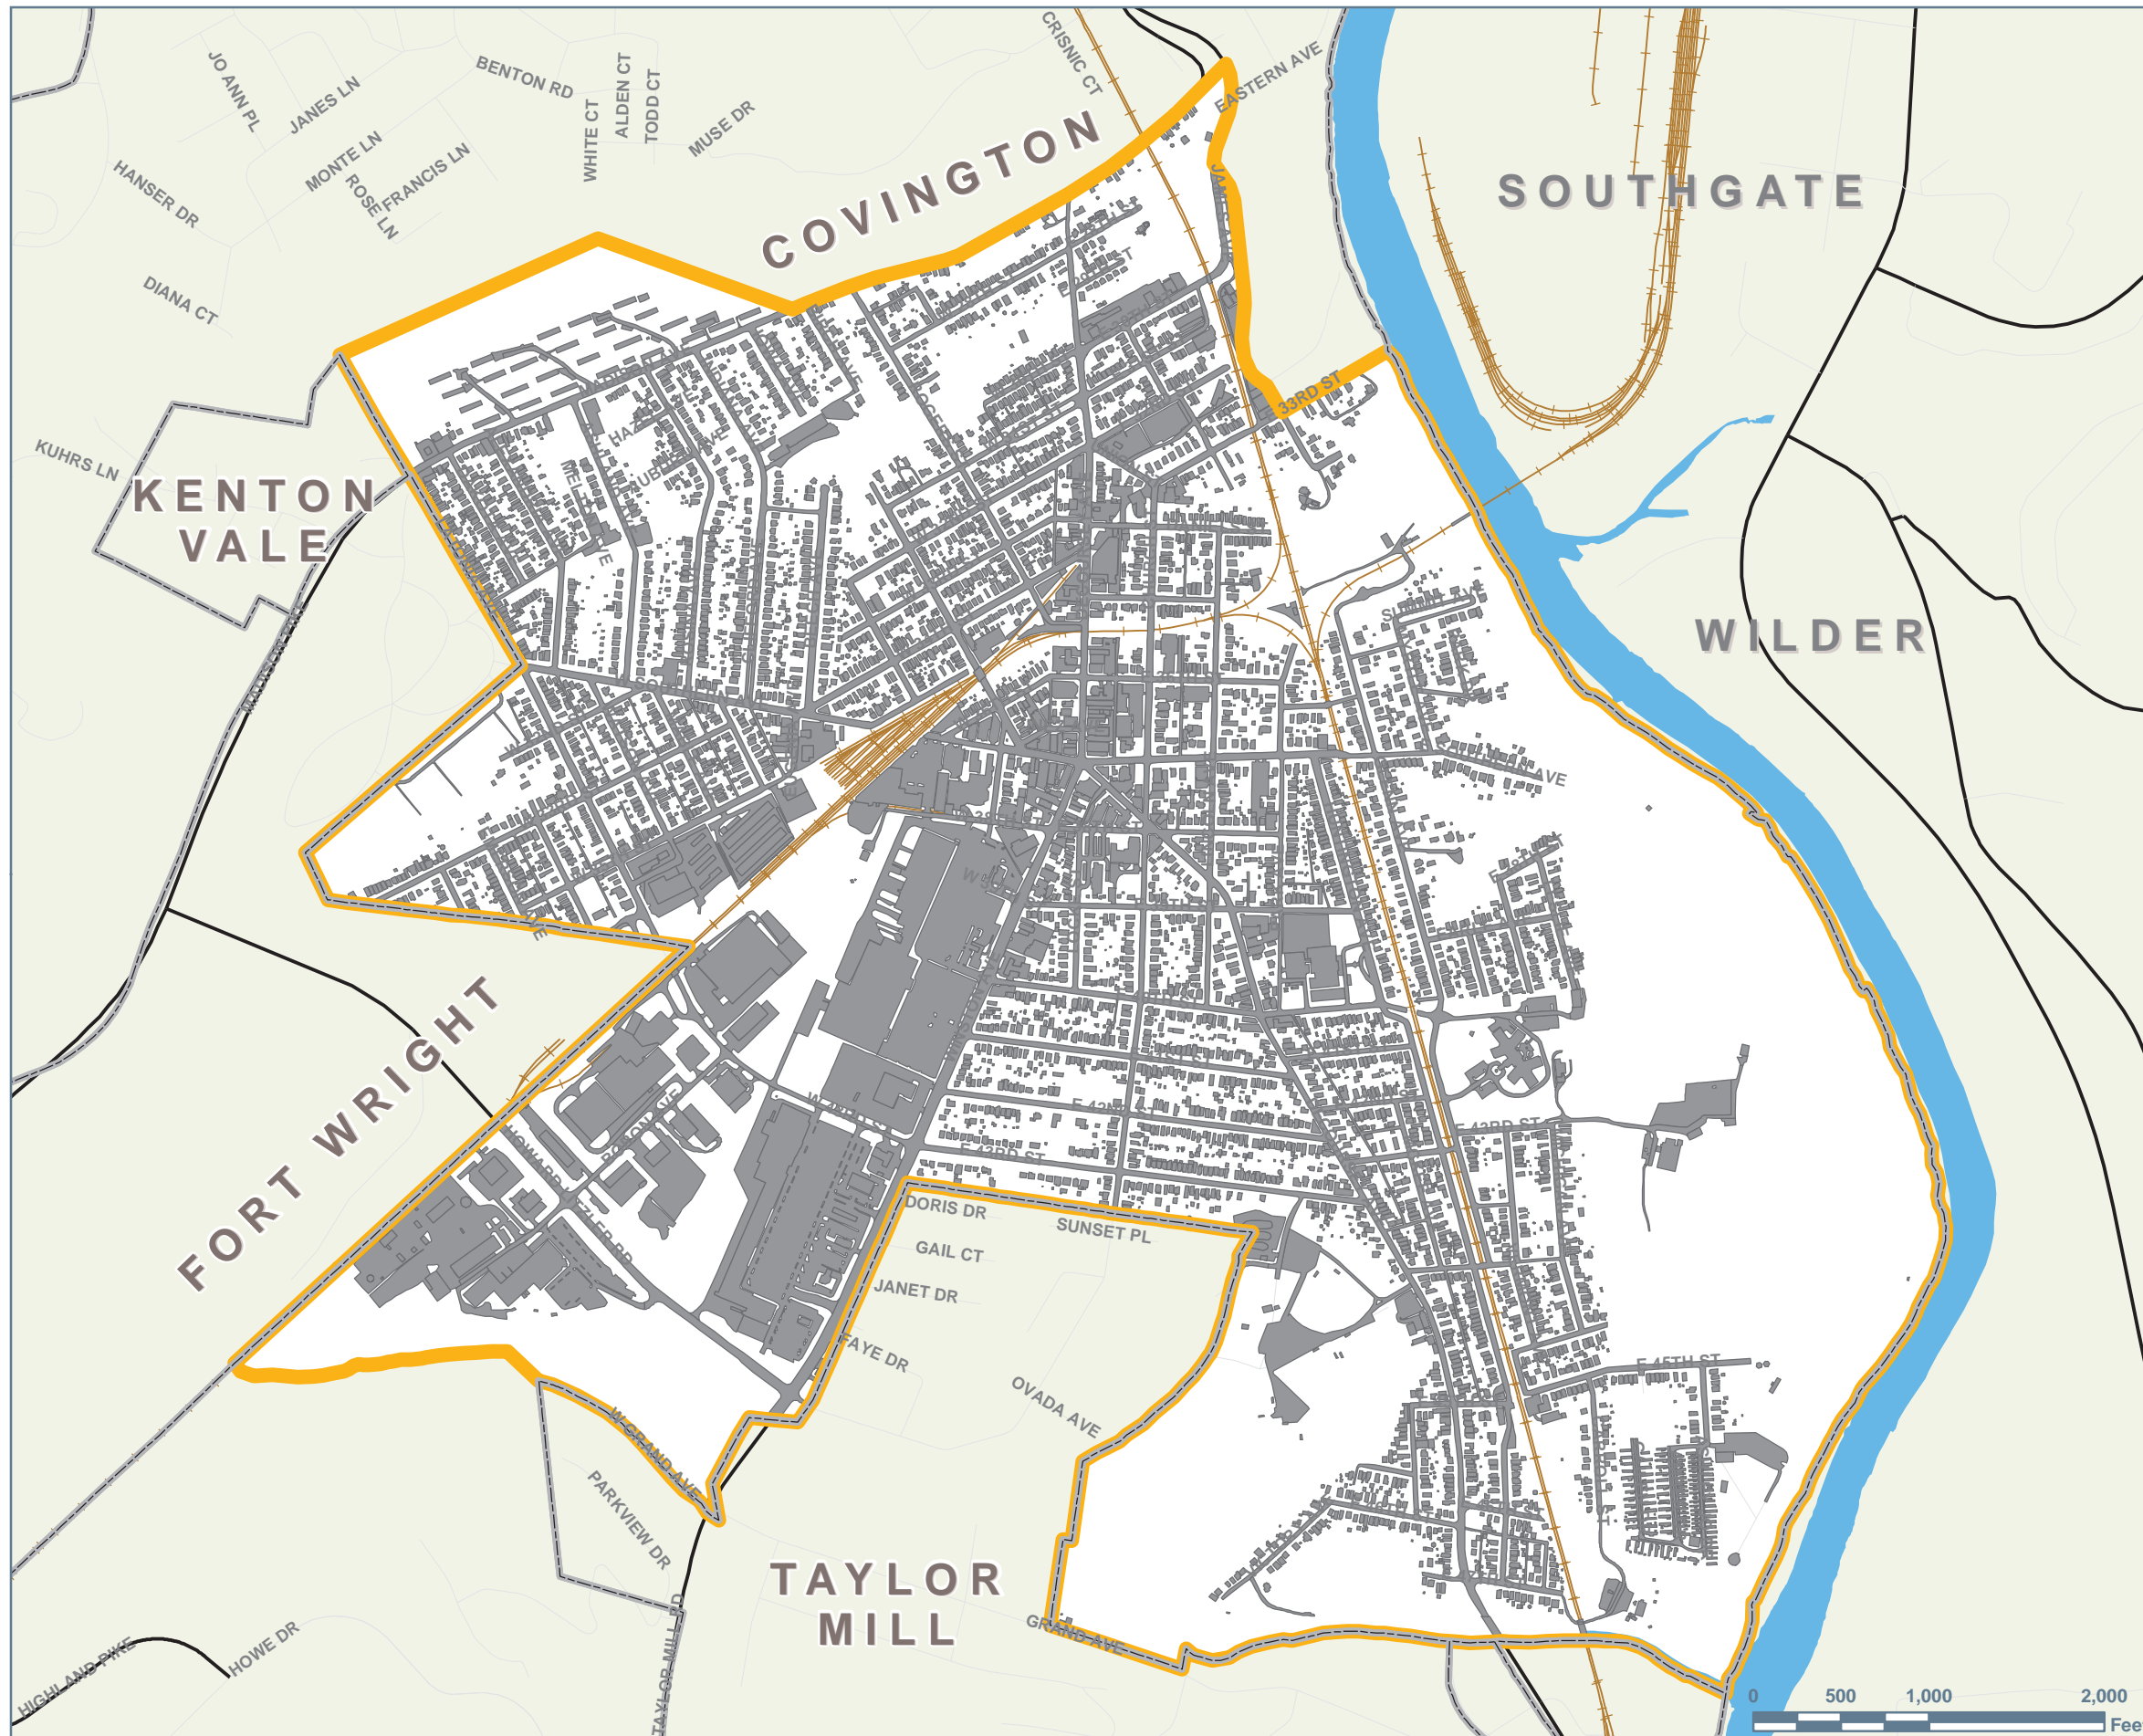
Map 4.4 Impervious Surfaces

Impervious Surface
Approximately 367 acres

Impervious Surface Percentage
Approximately 32% of study area

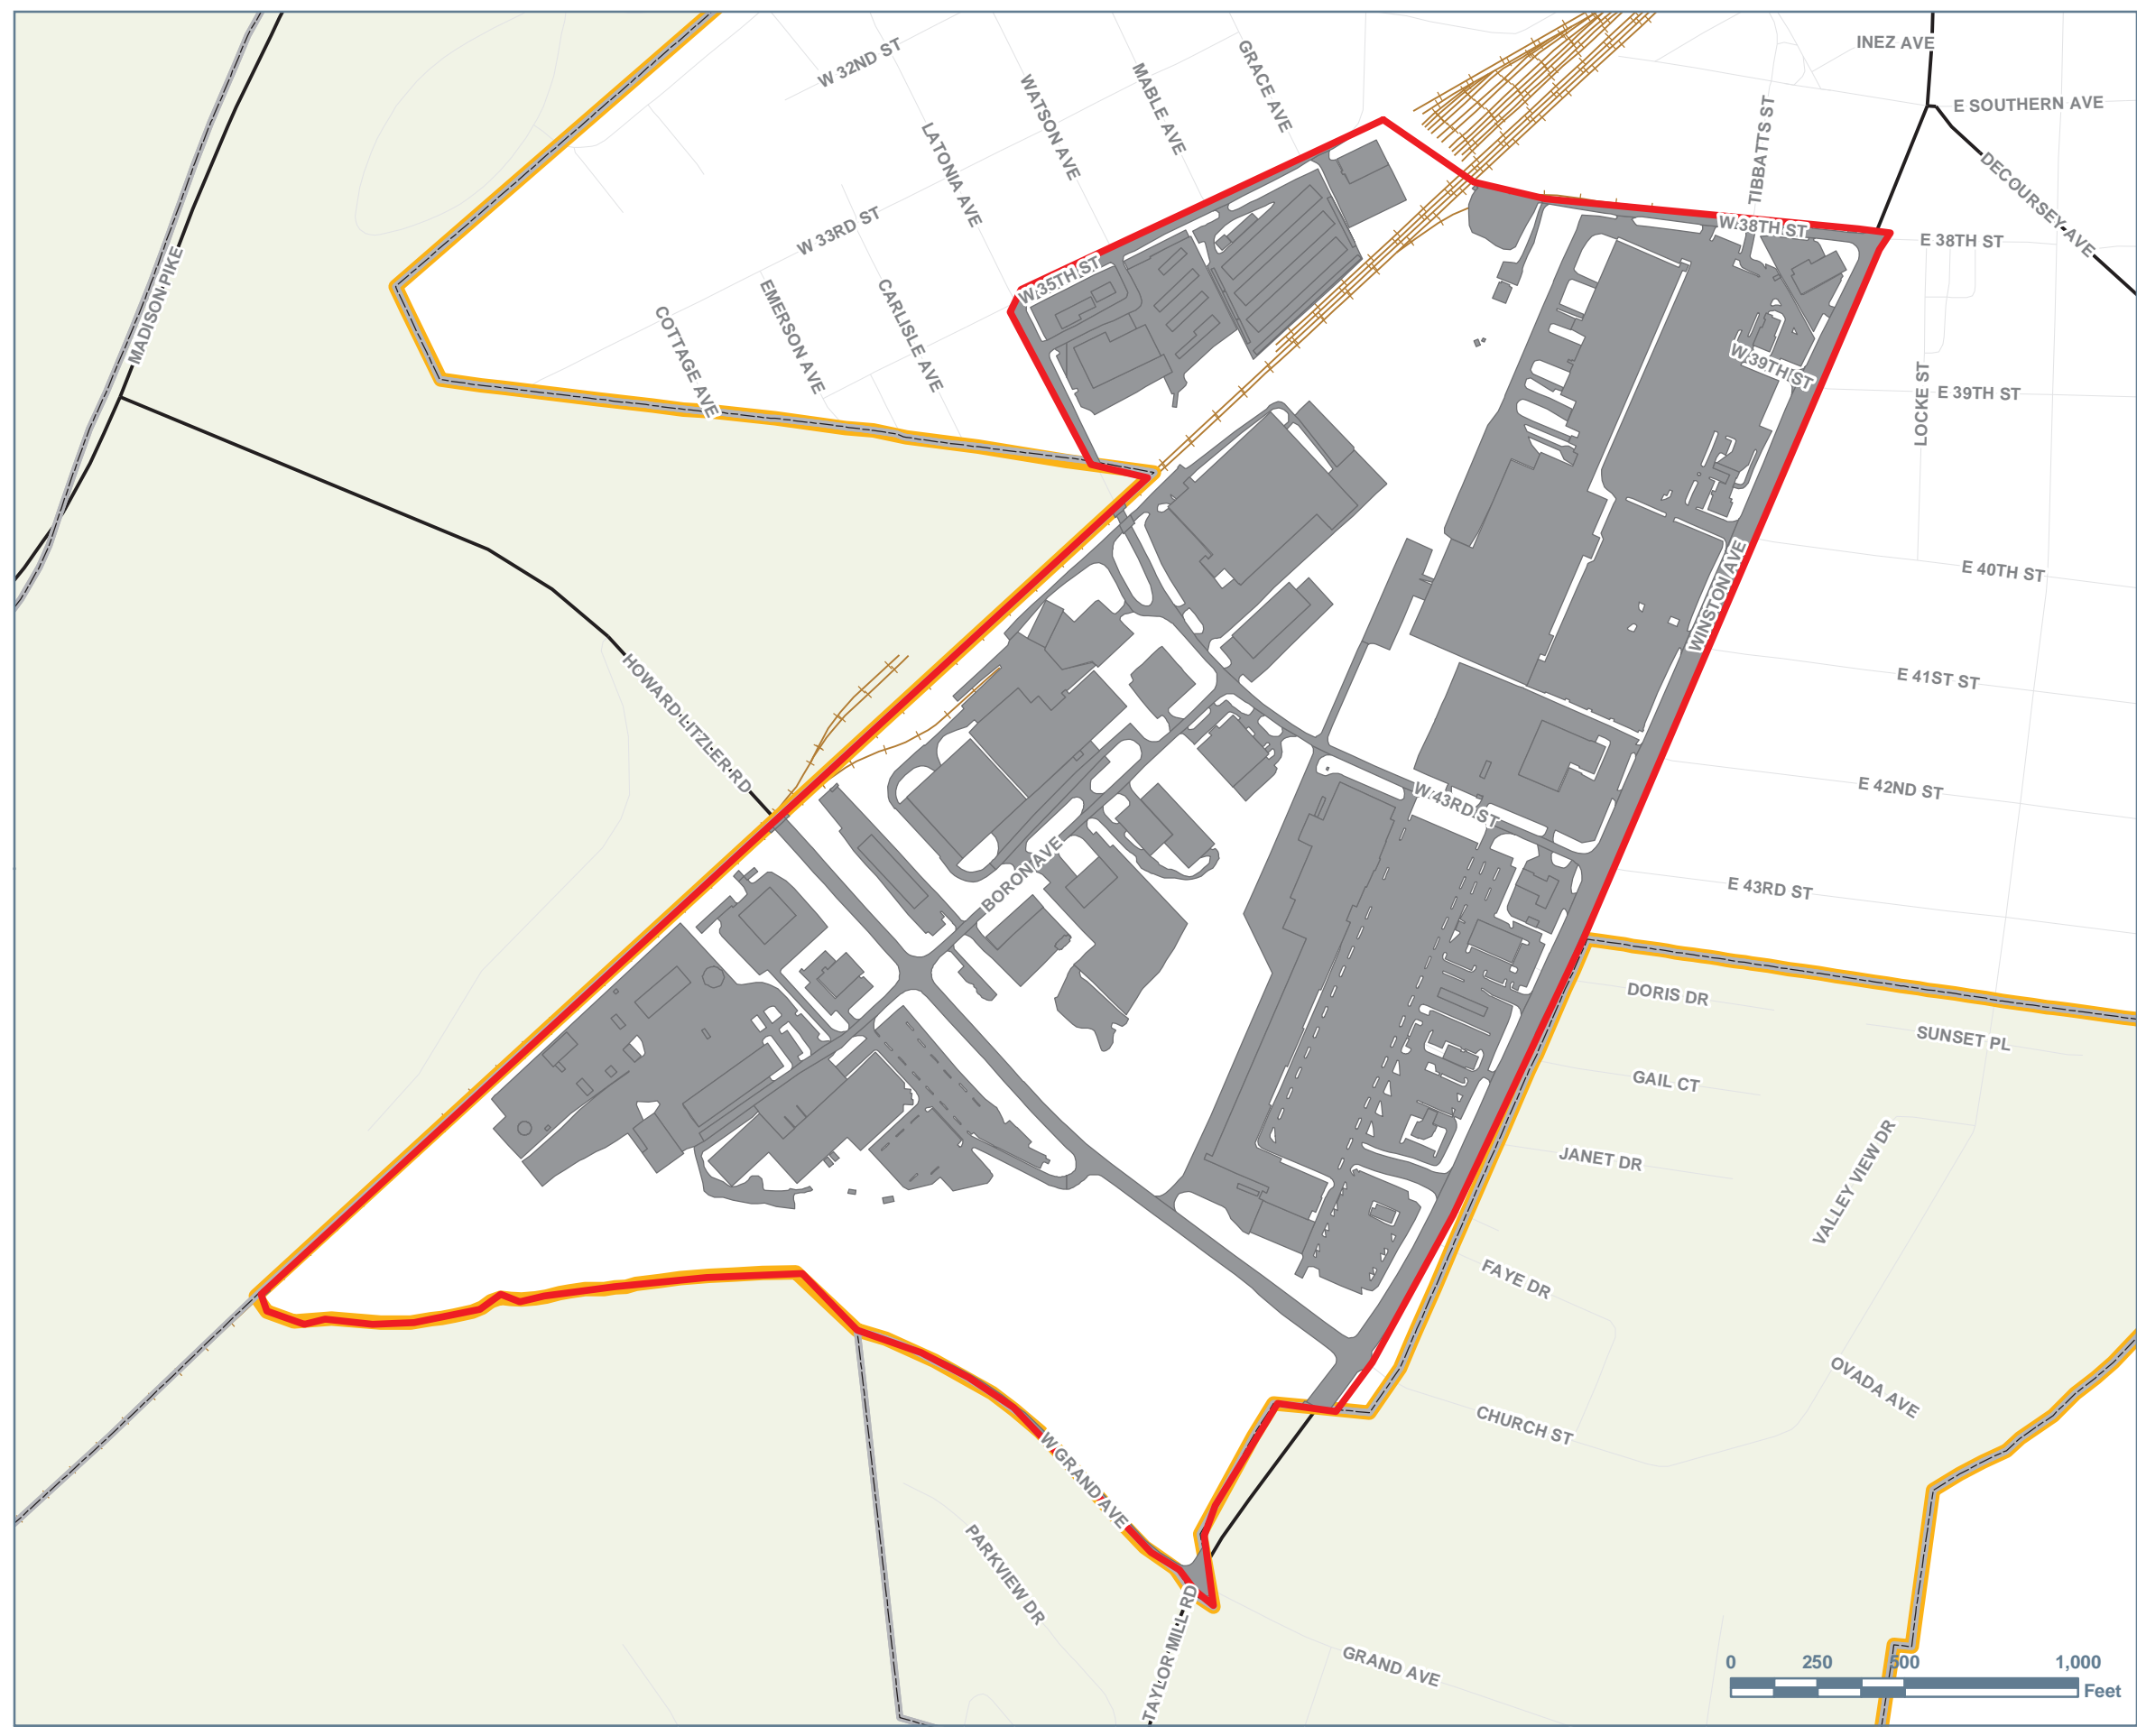
Map 4.5 Impervious Surface Detail

Impervious Surface Detail
 Approximately 106 acres

Impervious Surface Percentage
 Approximately 54% of detail area
